# **COMPREHENSIVE MOTOR VEHICLE SERVICES & CONSULTING Motor Vehicle Forensic Analysis Report**

**People of the State of New York v.**  
**Nauman Hussain**

CMVSC-18-VA-253

**REFERENCED INVOLVED SUBJECT VEHICLE:** 2001 Ford Excursion Stretch Limousine,  
VIN 1FMNU40S51EB10299

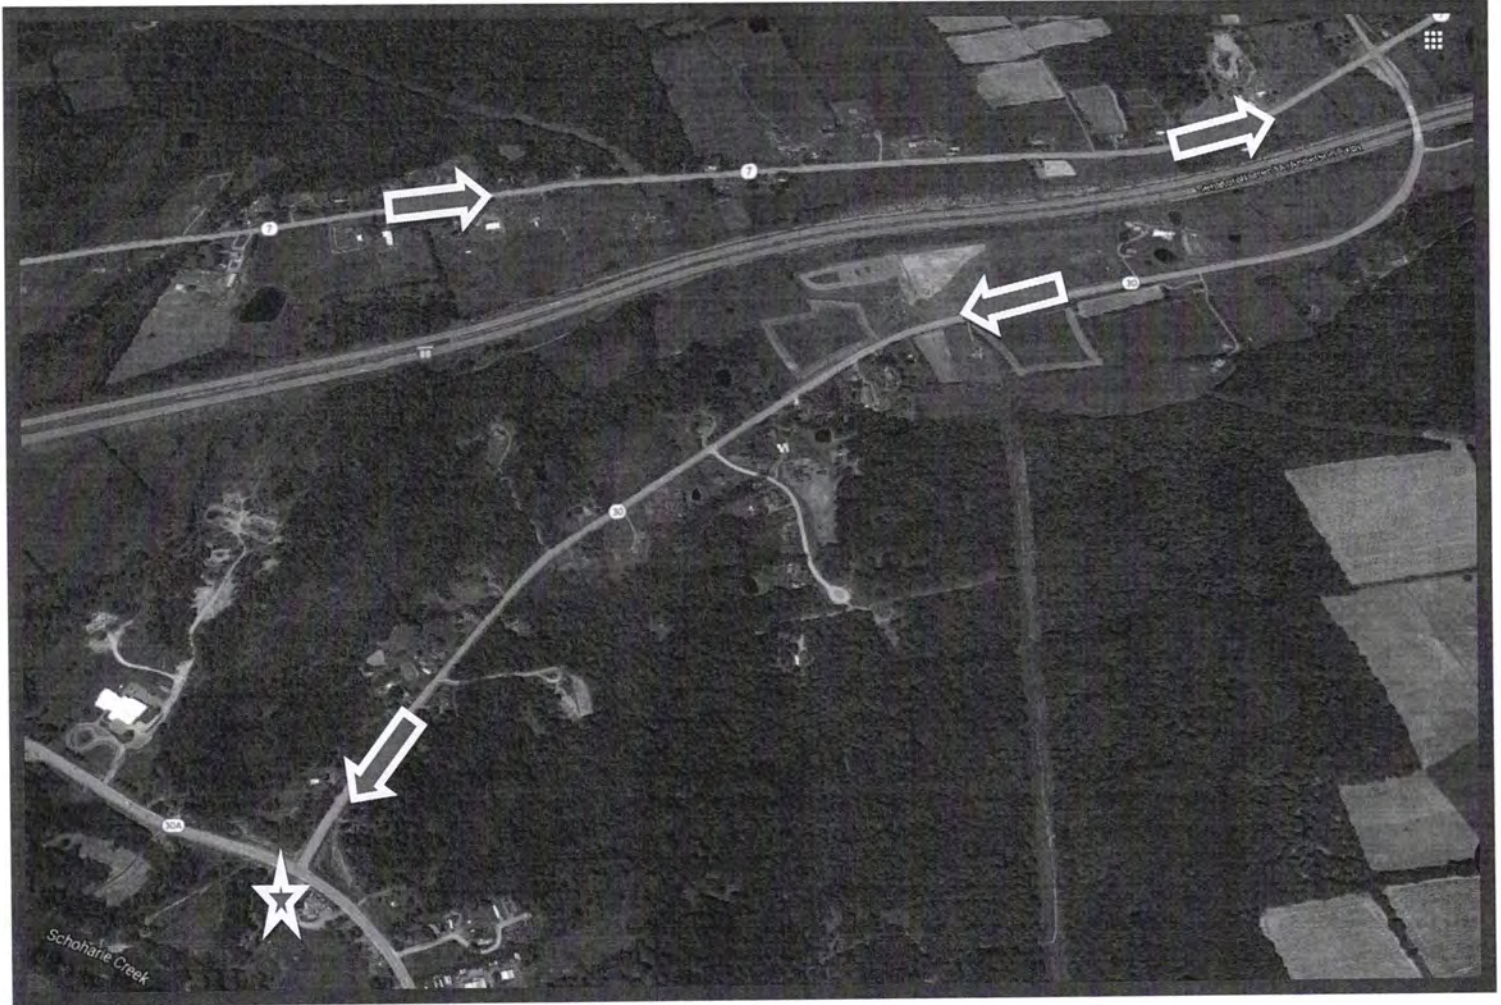
**Image No.1.** This aerial view, courtesy of Google Maps, depicts the approximate trajectory of the 2001 Ford Excursion stretch limousine prior to impacting the parked 2015 Toyota Highlander and the earthen embankment, located northerly of the Apple Barrel Country Store in Schoharie, New York. The Area of Impact is designated by the star symbol. NOTE: This image is not meant to represent the exact trajectory of the 2001 Ford Excursion stretch limousine, nor the area of impact. Rather, the image is for reference purposes only.

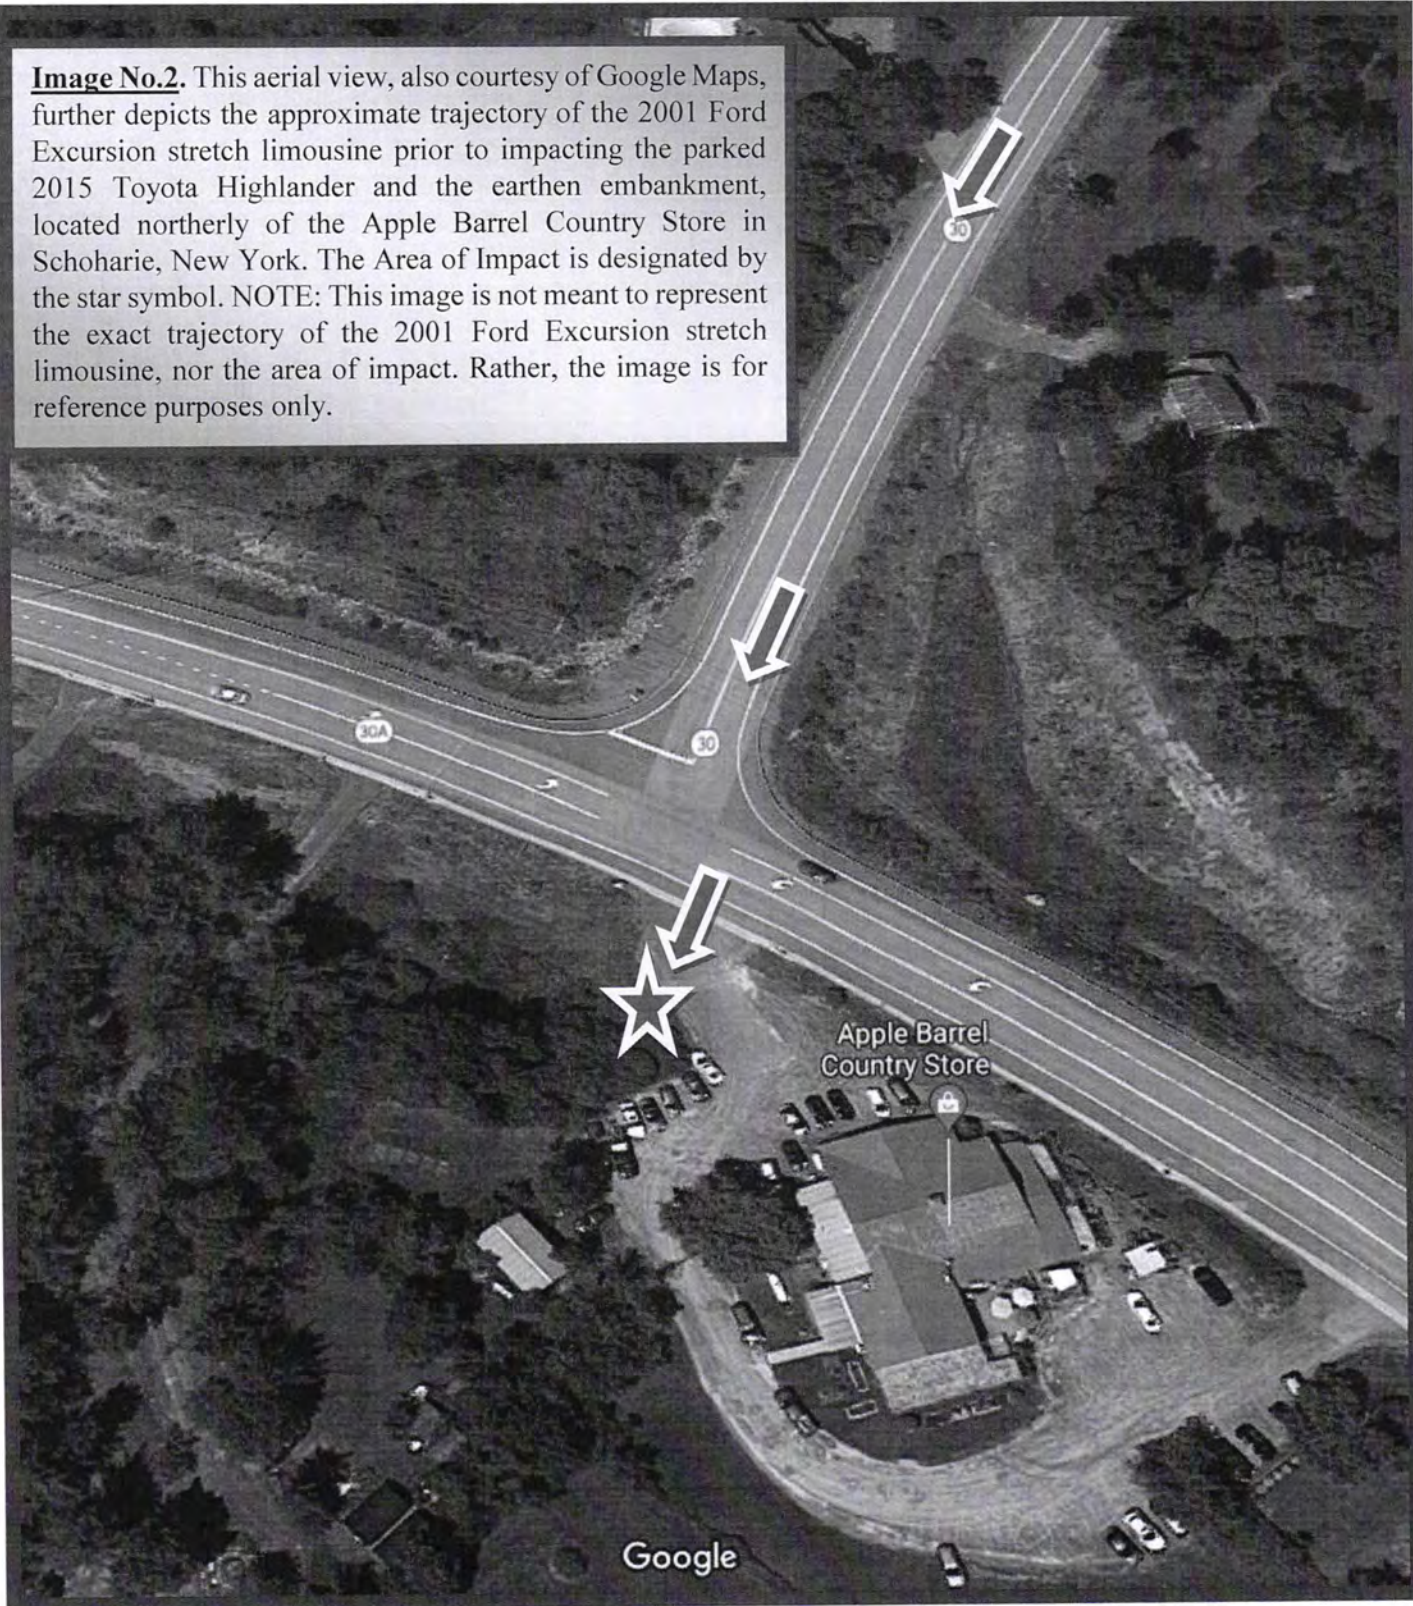
**Image No.2.** This aerial view, also courtesy of Google Maps, further depicts the approximate trajectory of the 2001 Ford Excursion stretch limousine prior to impacting the parked 2015 Toyota Highlander and the earthen embankment, located northerly of the Apple Barrel Country Store in Schoharie, New York. The Area of Impact is designated by the star symbol. NOTE: This image is not meant to represent the exact trajectory of the 2001 Ford Excursion stretch limousine, nor the area of impact. Rather, the image is for reference purposes only.

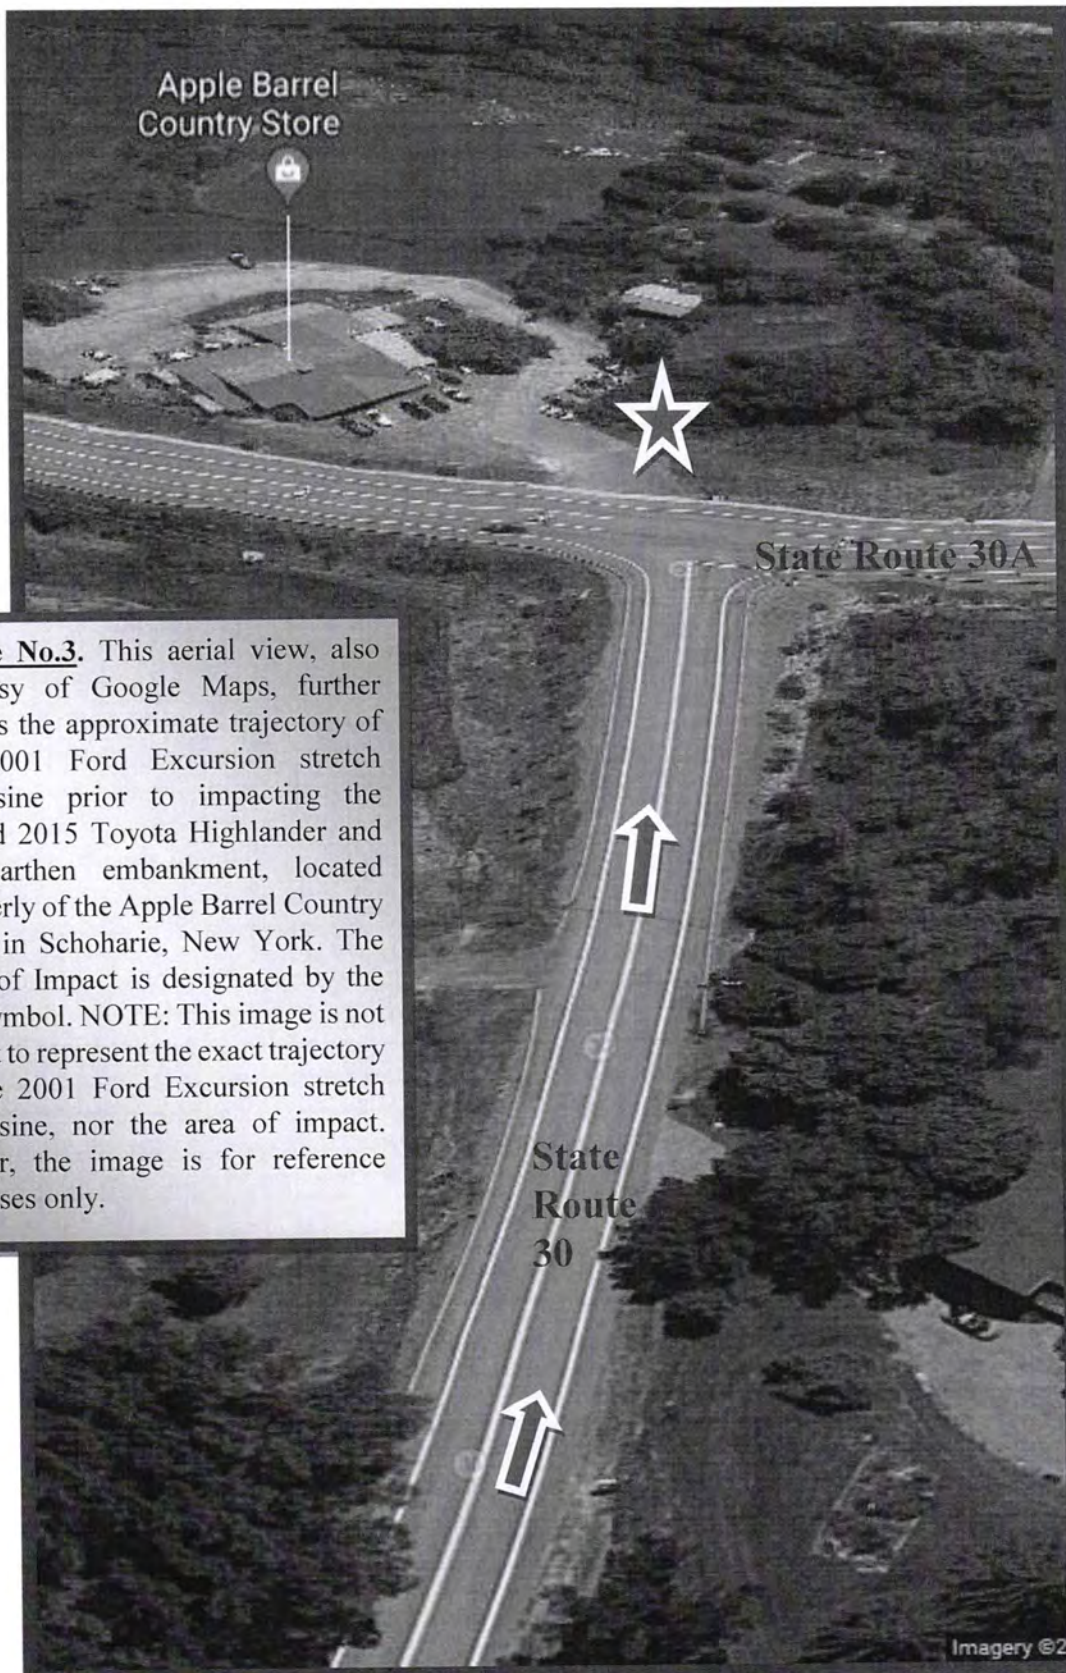
**Image No.3.** This aerial view, also courtesy of Google Maps, further depicts the approximate trajectory of the 2001 Ford Excursion stretch limousine prior to impacting the parked 2015 Toyota Highlander and the earthen embankment, located northerly of the Apple Barrel Country Store in Schoharie, New York. The Area of Impact is designated by the star symbol. NOTE: This image is not meant to represent the exact trajectory of the 2001 Ford Excursion stretch limousine, nor the area of impact. Rather, the image is for reference purposes only.

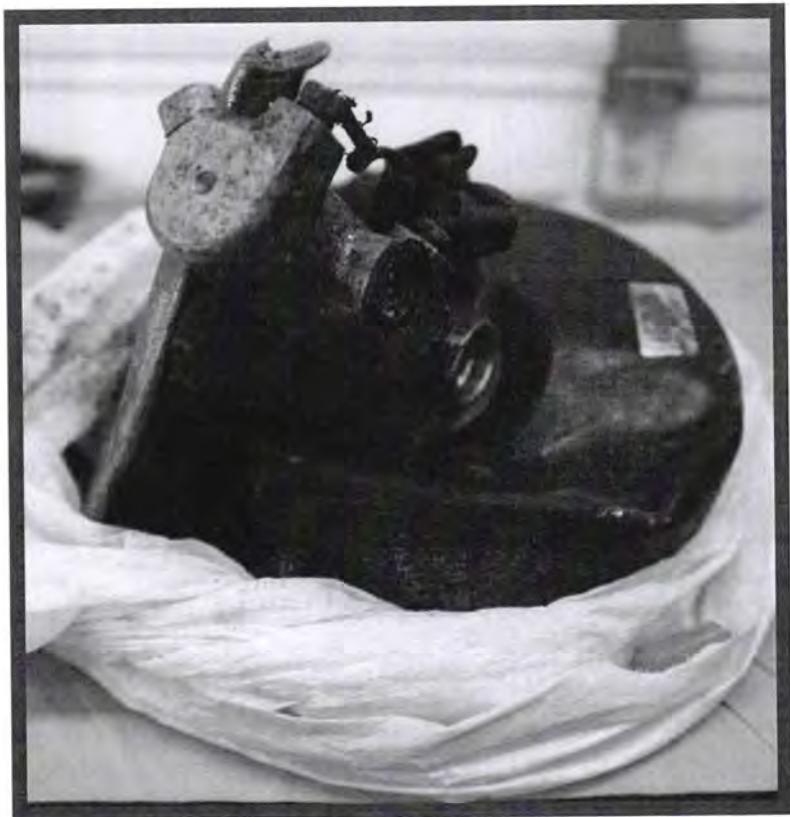
**Image No.40.** This photograph depicts the brake master cylinder and the power brake vacuum booster of the 2001 Ford Excursion stretch limousine during the period of individual component analysis. The severity of crash impact resulted in 1) separation of the brake master cylinder reservoir; 2) deformation of the front and rear steel brake tubing; and 3) deformation of the power brake vacuum booster housing.
